SNAP LAKE POWER HOUSE ENGINE CONDITION ANALYSIS

MAR 9-15, 2022

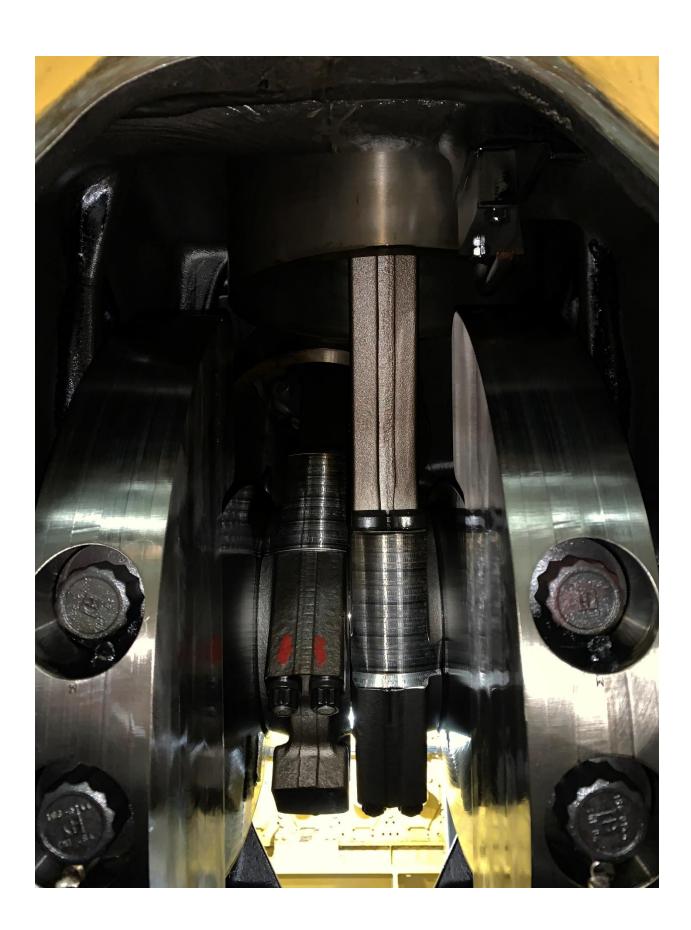
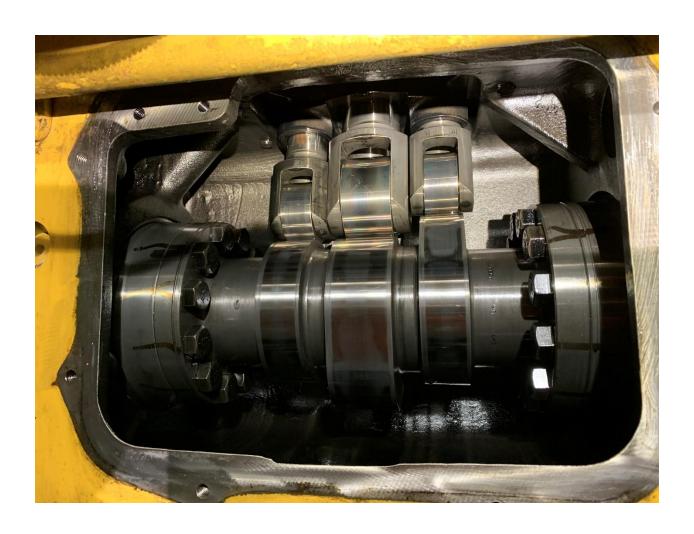
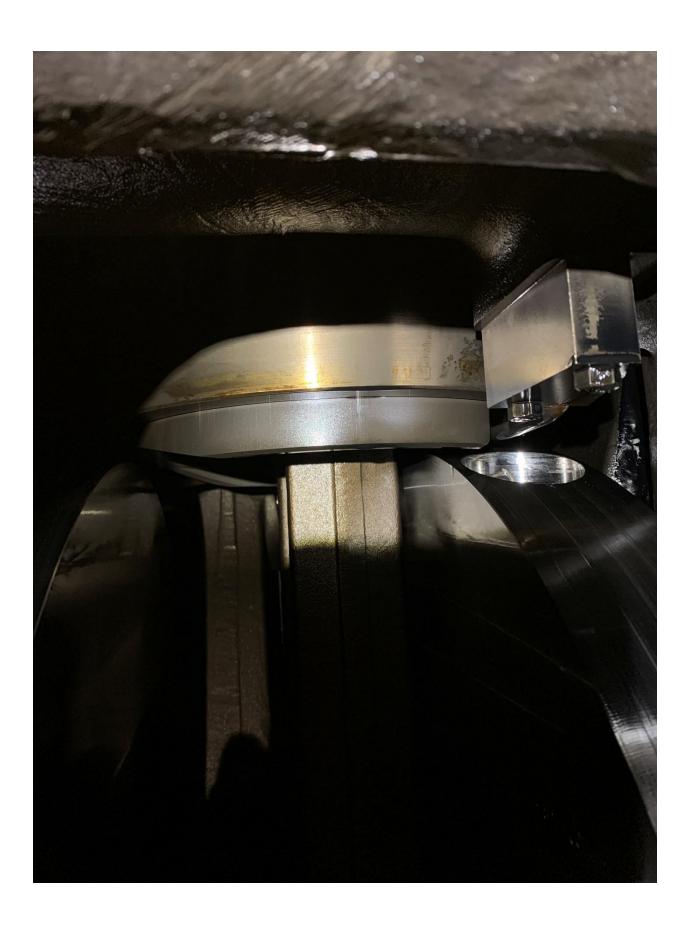
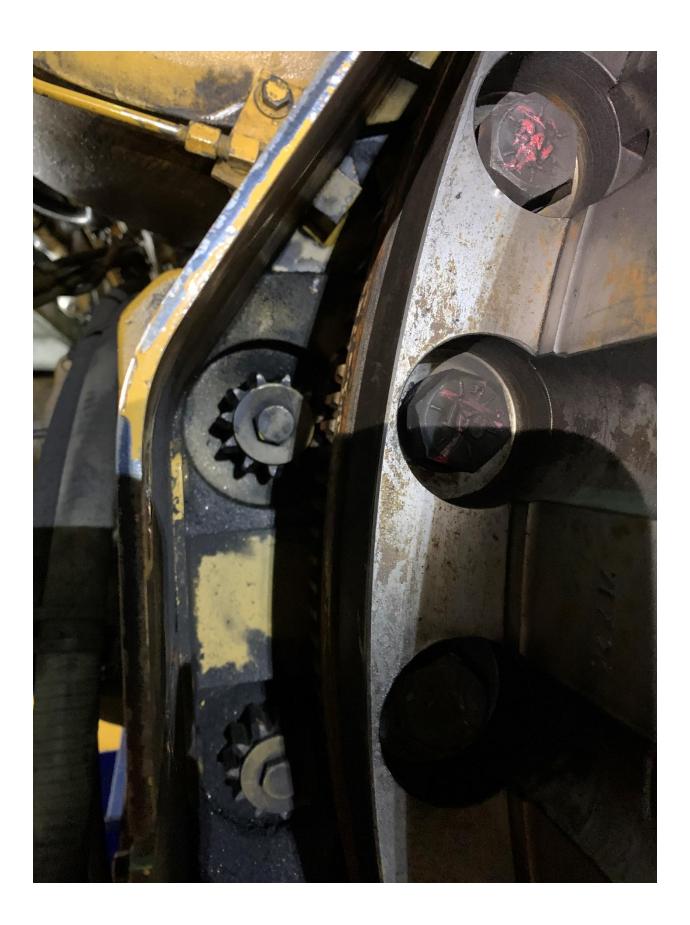
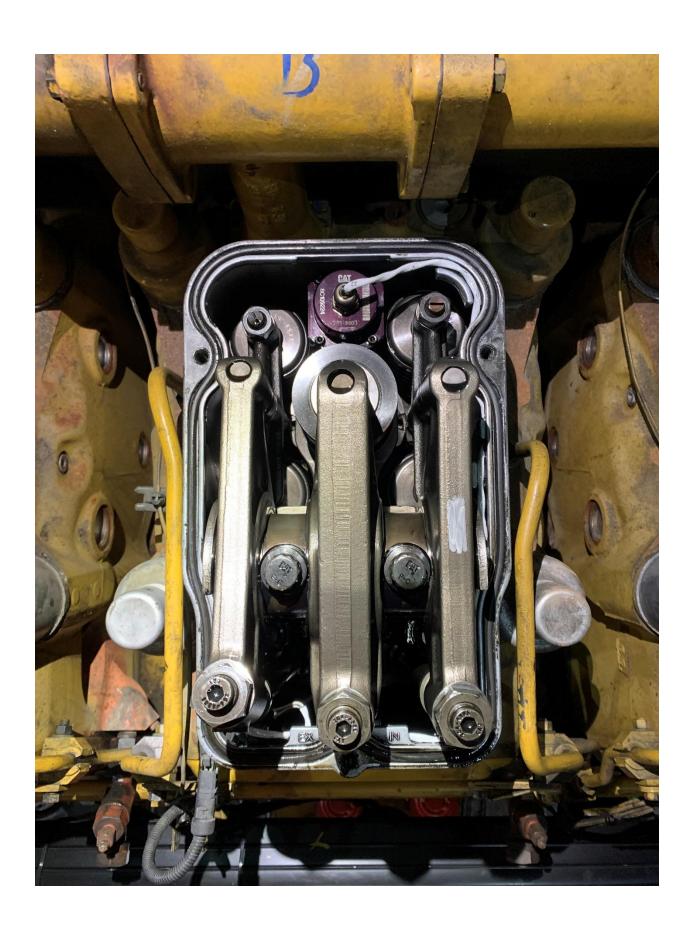
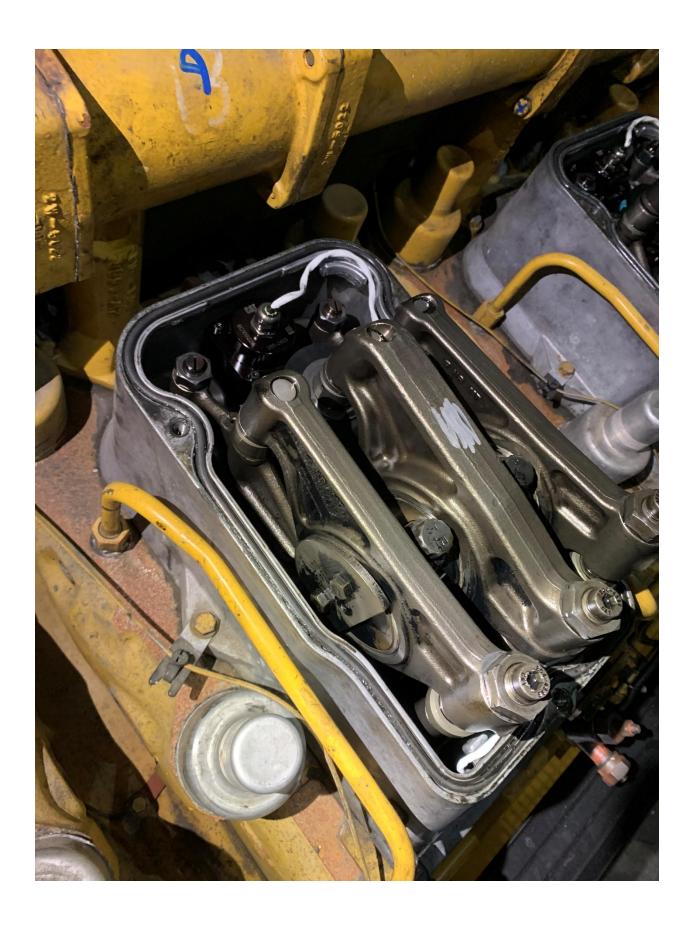
PICTURES TAKEN, AND BORESCOPE PICTURES TAKEN WHILE CLOSELY INSPECTING UNIT.

- LINERS / CYLINDERS SHOW VERY GOOD X-HATCH PATTERN
- VISIBLE SECTION OF PISTON SKIRTS APPEAR VERY GOOD CONDITION
- LIFTERS, FOLLOWERS, CAMSHAFT LOBES ALL APPEAR TO BE IN VERY GOOD CONDITION.

ATTACHED ARE PICTURES OF COMPONENTS. ALL COMPONENTS LOOK IN IDENTICAL CONDITION.
